SENTEC Testing Laboratory Inc.

REPORT XYZ-005

ASSESSMENT OF A SILVER CONDUCTIVE EPOXY

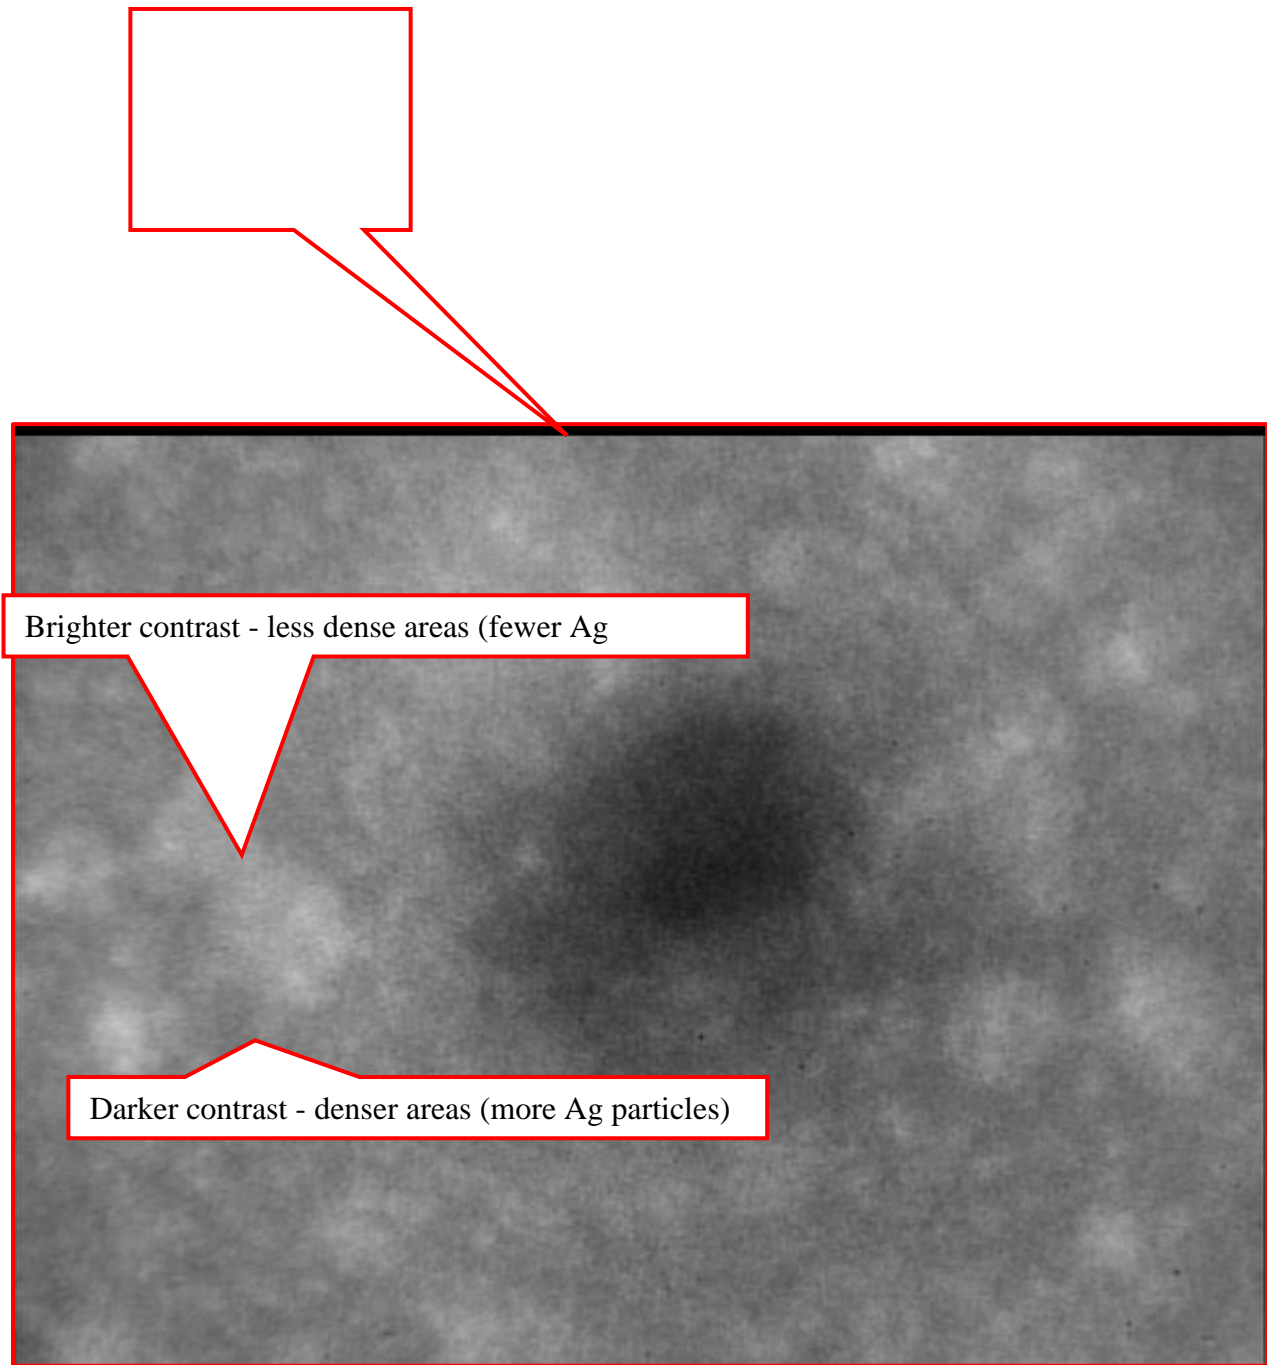
of X-ray inspection of the areas of interest, no voiding but rather areas with different shades of grey were

observed in the conductive epoxy of both headlamps – Figs. 1 and 2. Brighter contrast areas indicate the

presence of fewer Ag particles, compared to the darker looking areas.

Brighter contrast - less dense areas (fewer Ag

Darker contrast - denser areas (more Ag particles)

Figure 1. Typical results of X-ray inspection of a fist headlamp (37.4 Ω).

Cross-sectional SEM analysis of the areas might be beneficial in understanding the distribution of the

particles in the epoxy.

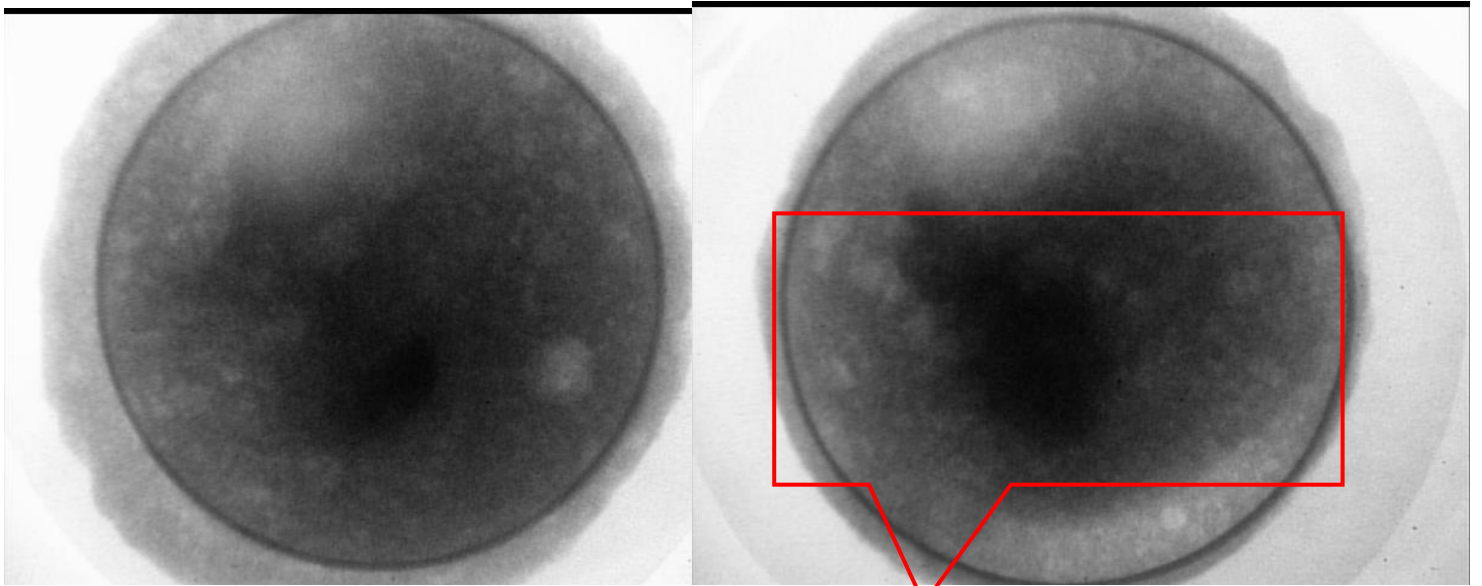
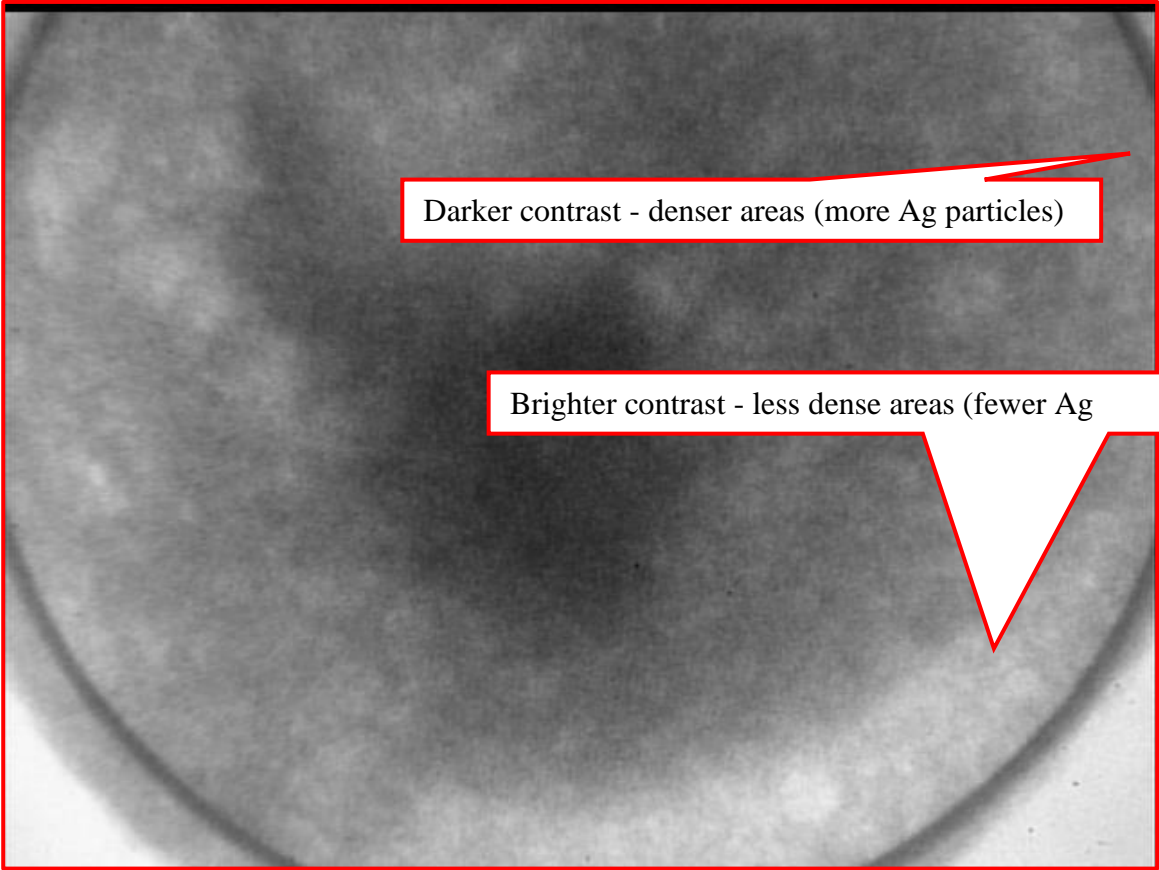
Figure 2. Typical results of X-ray inspection of the second headlamp (300 Ω).

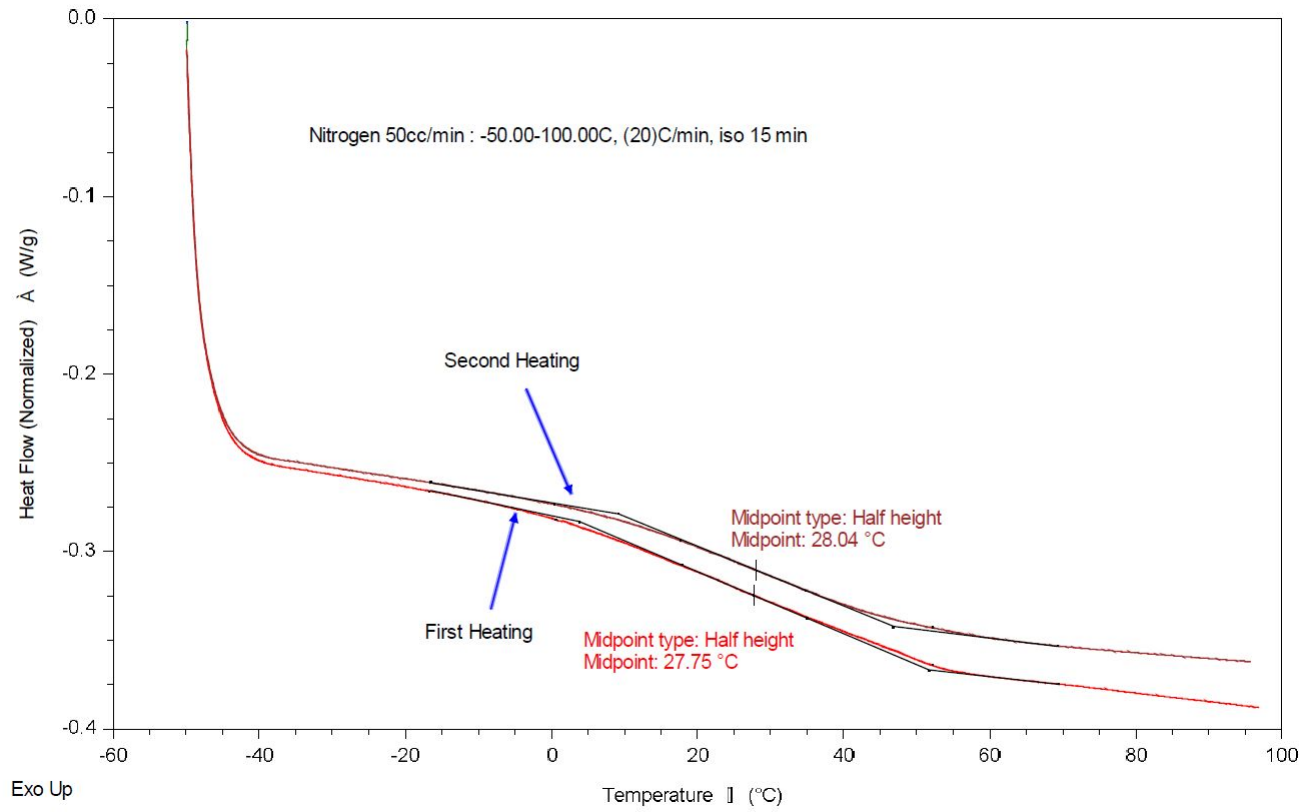
DSC analysis of the epoxy showed that it was properly cured as glass transition temperature (T_g) was

measured at 28⁰C during both cycles of heating - Fig 3.

Figure 3. Typical results of the DSC test. The epoxy was cured properly.
