SENTEC Testing Laboratory Inc.

REPORT XYZ-005

ASSESSMENT OF A SILVER CONDUCTIVE EPOXY

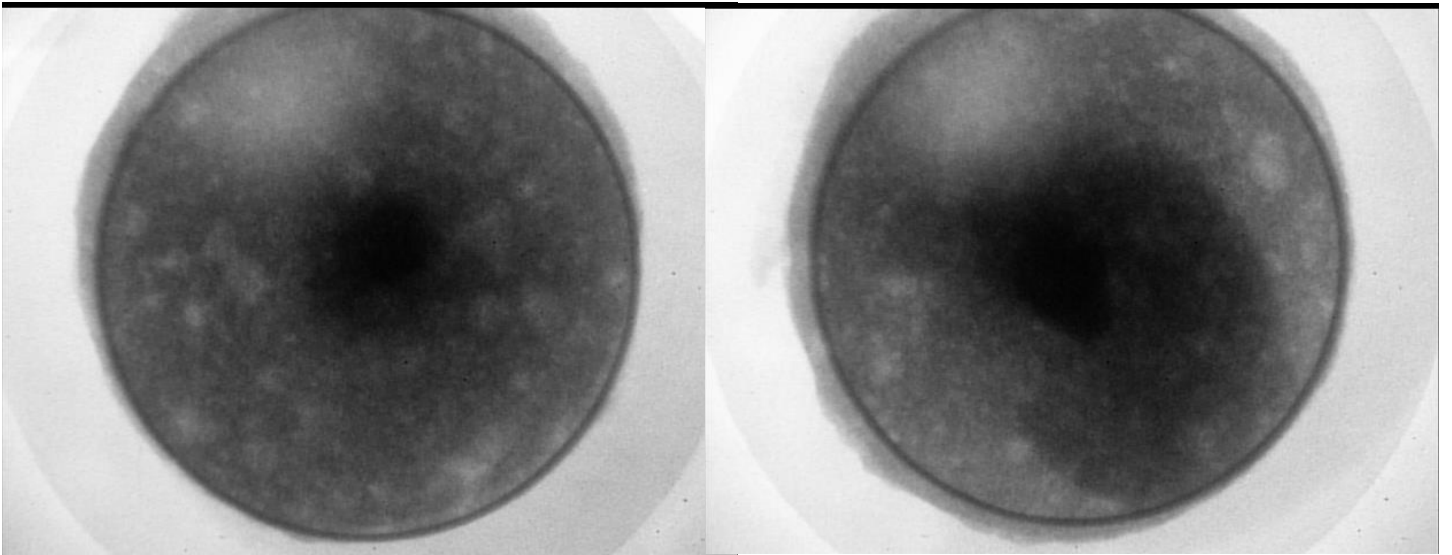
observed in the conductive epoxy of both headlamps – Figs. 1 and 2. Brighter contrast areas indicate the

Brighter contrast - less dense areas (fewer Ag
